INSPECTION REPORT

For the Property at:
123 MAIN ST.
MANSFIELD, OH 44906

Prepared for: JOHN SMITH
Inspection Date: Monday, September 9, 2019
Prepared by: Joshua Wendling

RE: Report No. 1693
123 Main St.
Mansfield, OH
44906

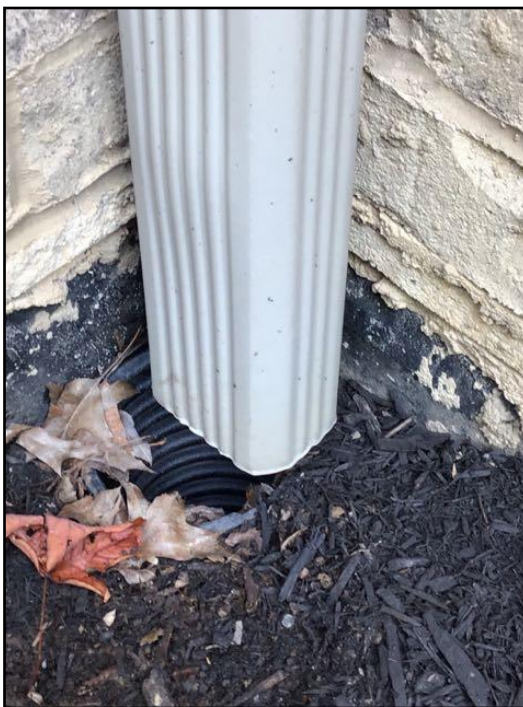
2. Condition: • Gap between connection.

Location: Rear

Gap between connection.

Task: Repair to prevent water from coming back toward the foundation

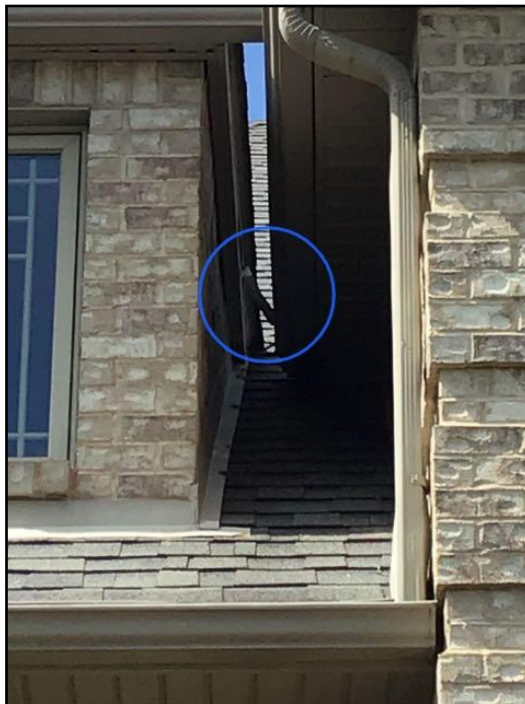
3. Condition: • Damaged/Loose

This appears to be a gutter strap.

Location: Front

Damaged/Loose

Task: Repair

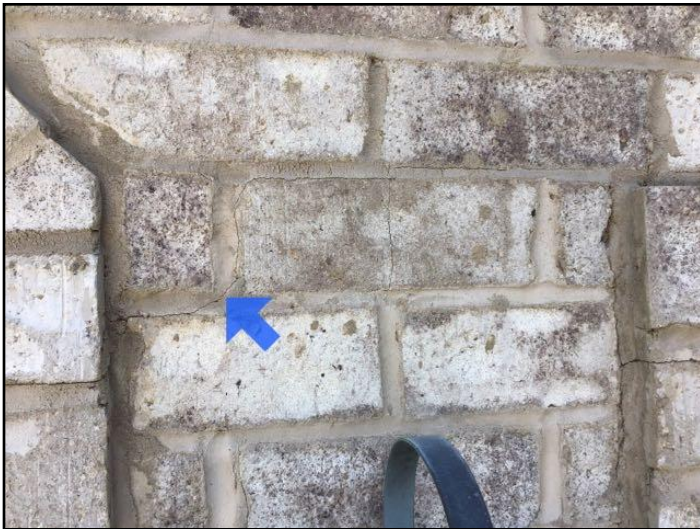
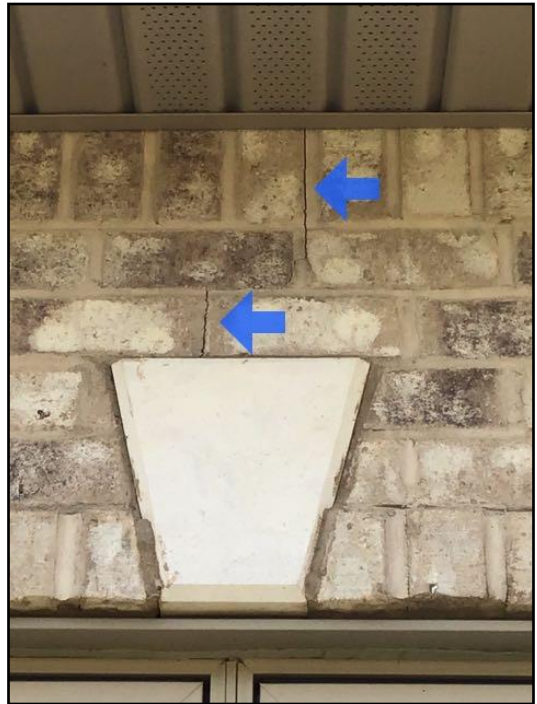
5. Condition: • Minor cracks noted in areas. Repair/seal as needed.

Minor cracks noted in areas. Repair/seal as...

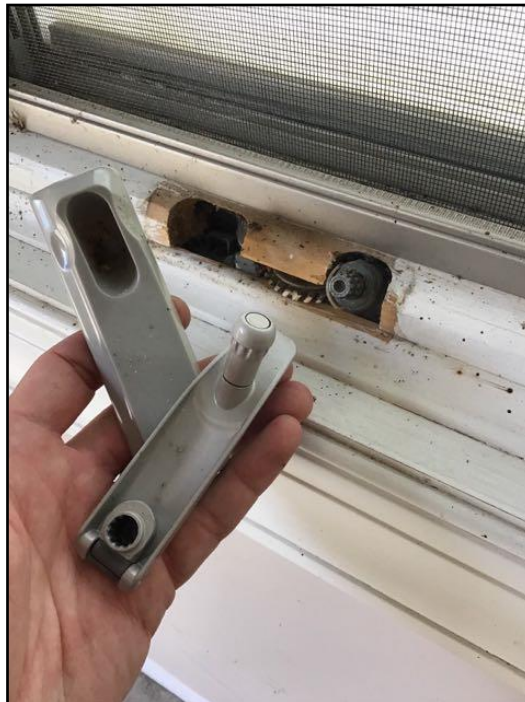
6. Condition: • Missing or loose hardware. Repair/Replace.

Location: Garage

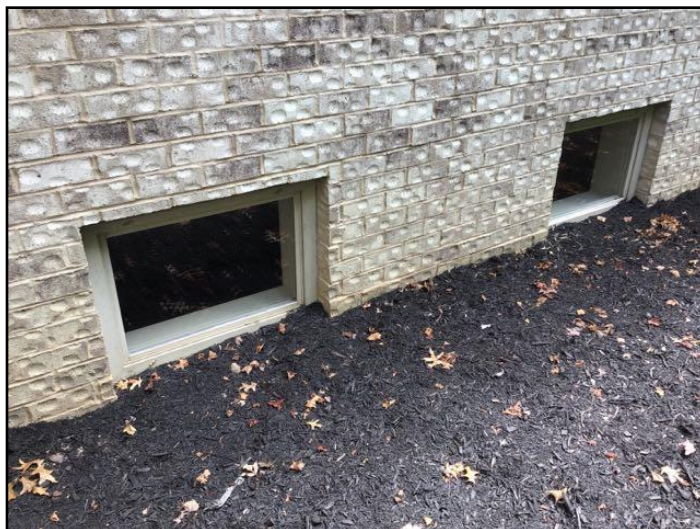
7. Condition: • Too close to grade. This is a vulnerable area for water intrusion. Re-grade.

Location: Rear

Too close to grade. This is a vulnerable...

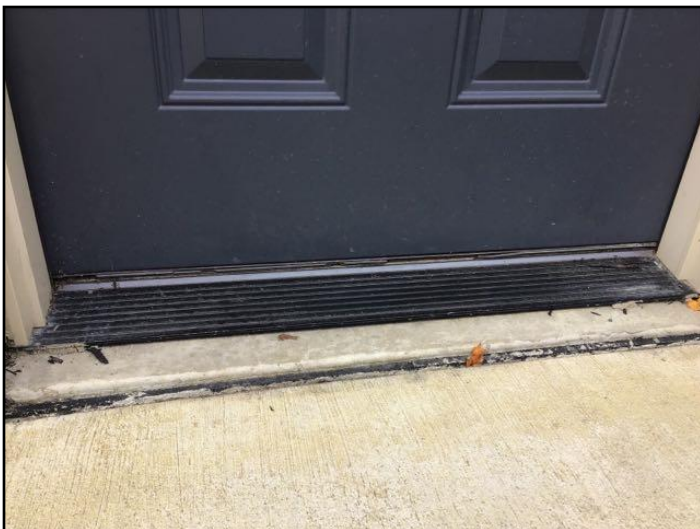
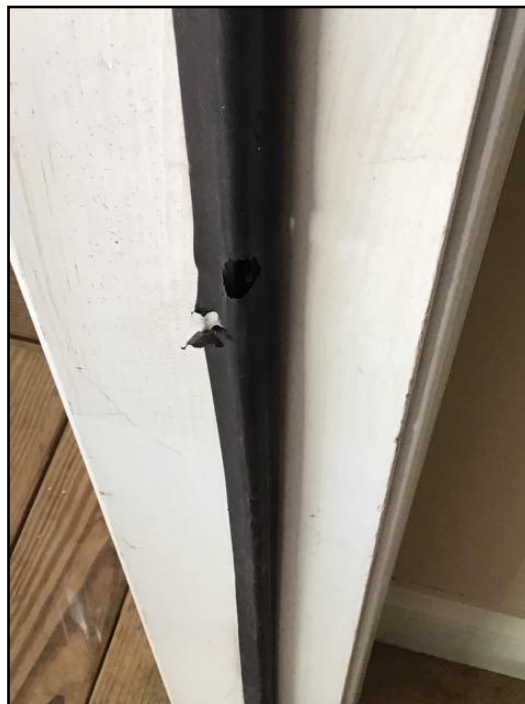
9. Condition: • Damaged weather seal.

Location: Man Door to Garage

Damaged weather seal.

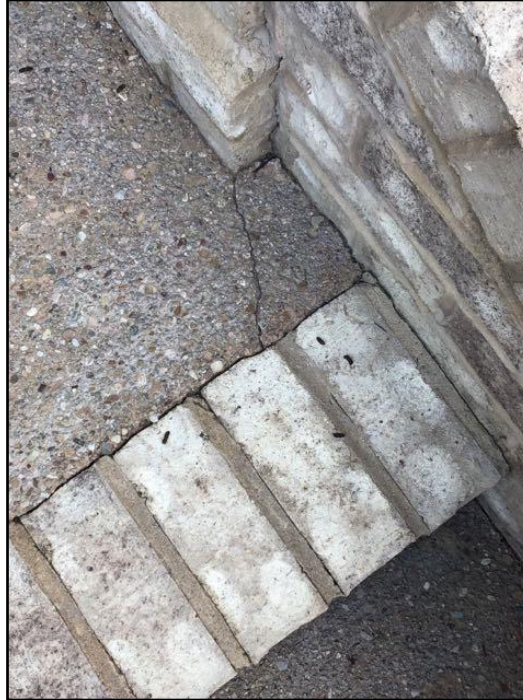
10. Condition: • Minor crack noted. Monitor and repair as needed.

Location: Front

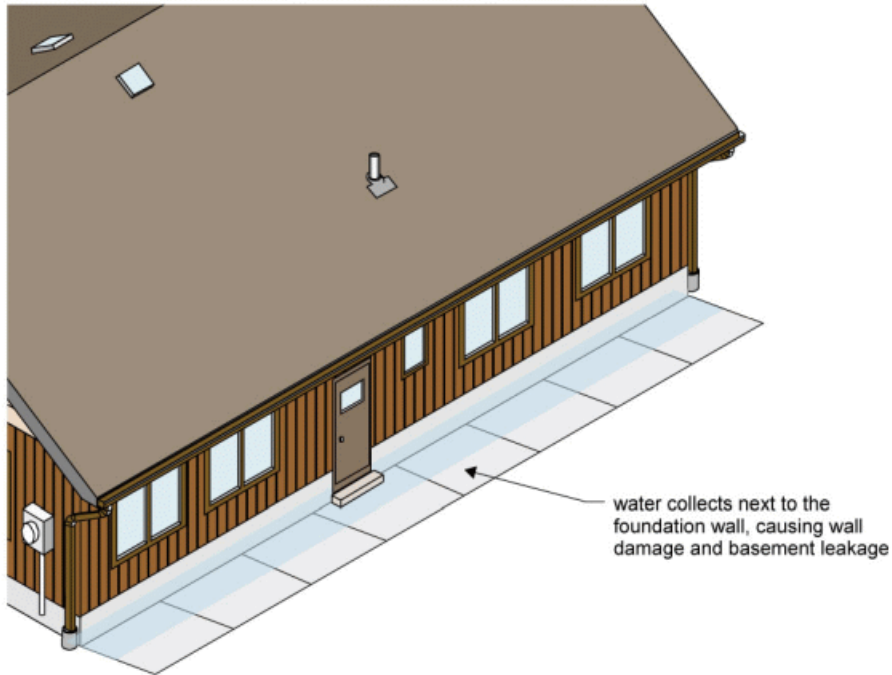
Walk/patio sloping towards house

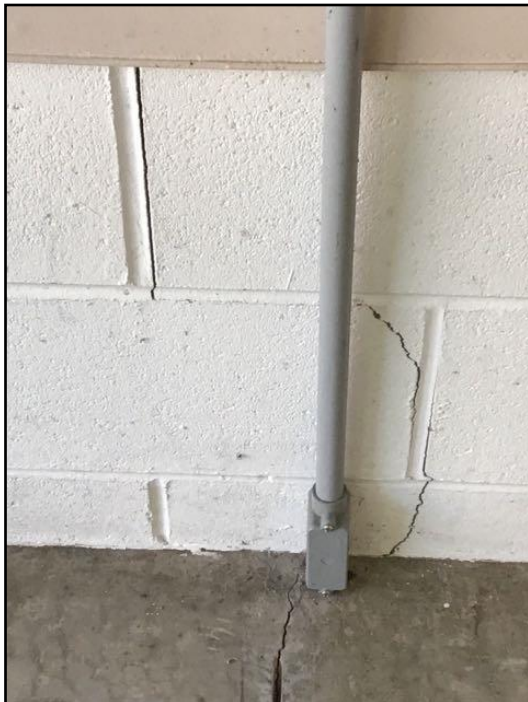
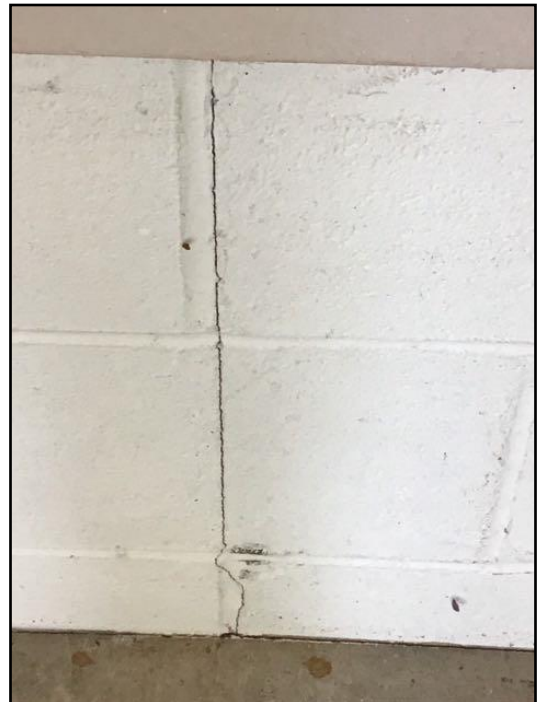
15. Condition: • Cracks noted on block. Monitor for future cracking and repair as needed.

Task: Seal as desired

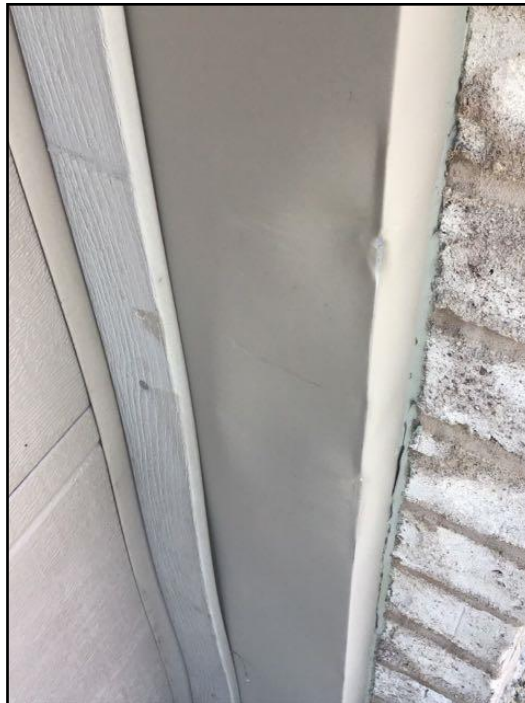
16. Condition: • Mechanical damage noted around the garage trim. Repair/replace as needed.

Mechanical damage noted around the garage...

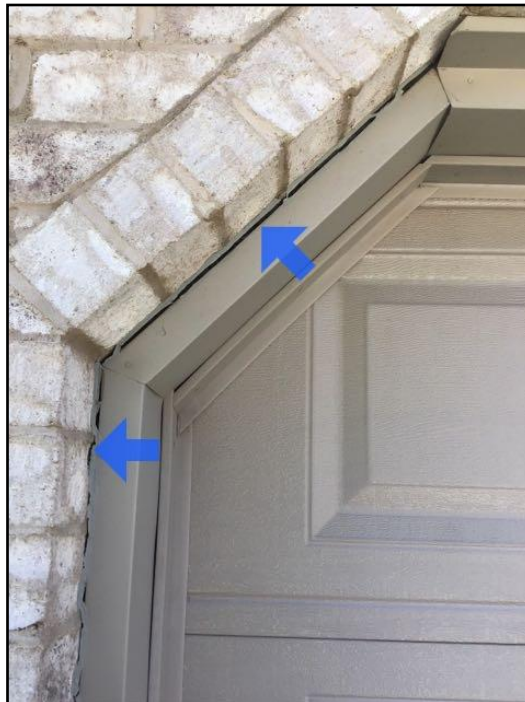
17. Condition: • Recommend caulking around the garage door trim to keep wind driven rain and pests from entering the space.

Recommend caulking around the garage door...

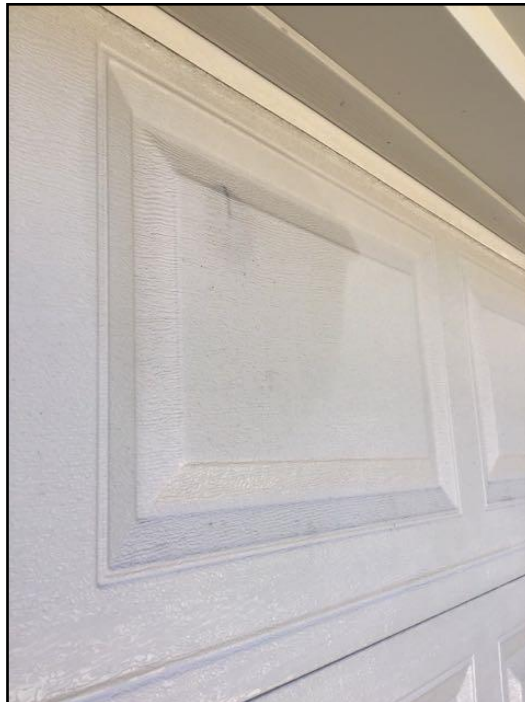
19. Condition: • Minor mechanical damage noted on the garage door. Repair as needed.

Minor mechanical damage noted on the garag...

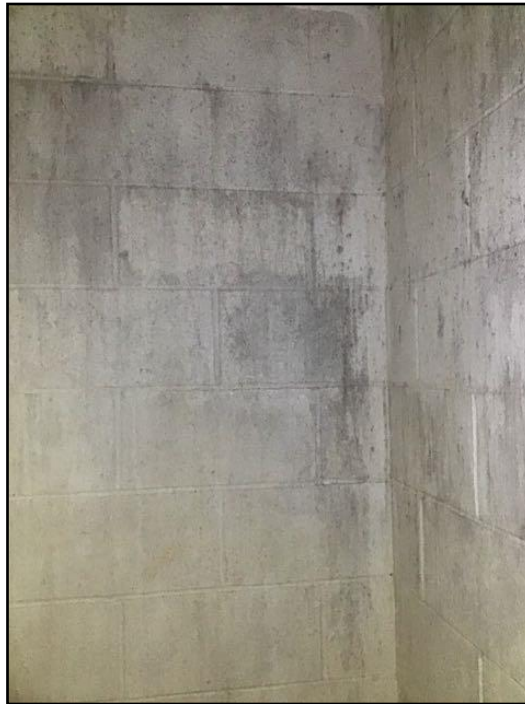
Condition: • Possible microbial growth noted

Location: Sump Pump Room

20. Condition: • Possible microbial growth noted

Possible microbial growth noted

Task: Clean

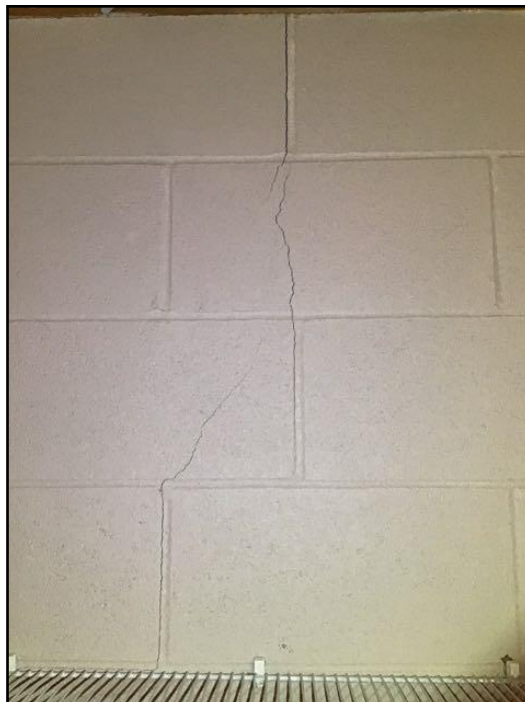
Condition: • Crack(s) noted on the basement foundation. Monitor for worsening cracking and repair as needed. If cracks widen overtime we recommend further evaluation by a licensed contractor. Seal crack(s) as needed to prevent water from entering the space.

21. Condition: • Crack(s) noted on the basement foundation. Monitor for worsening cracking and repair as needed. If cracks widen overtime we recommend further evaluation by a licensed contractor. Seal crack(s) as needed to prevent water from entering the space.

Crack(s) noted on the basement foundation....

Task: Seal cracks

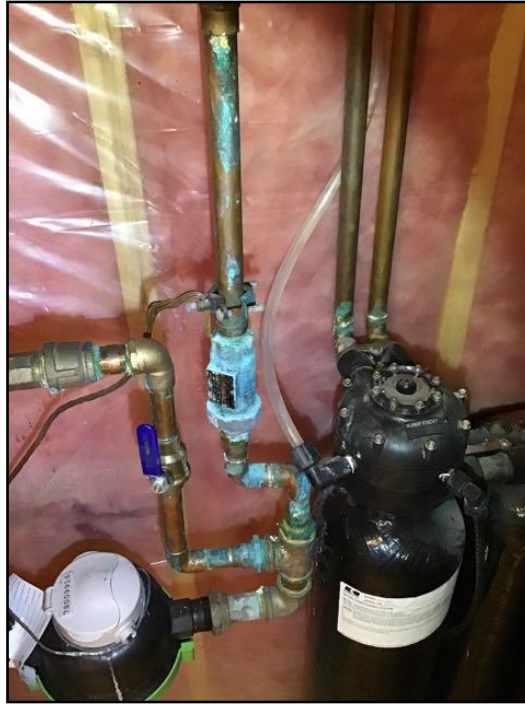
25. Condition: • Corrosion/Calcium buildup noted on some supply lines. Monitor for leaks and repair/replace as needed.

Corrosion/Calcium buildup noted on some...

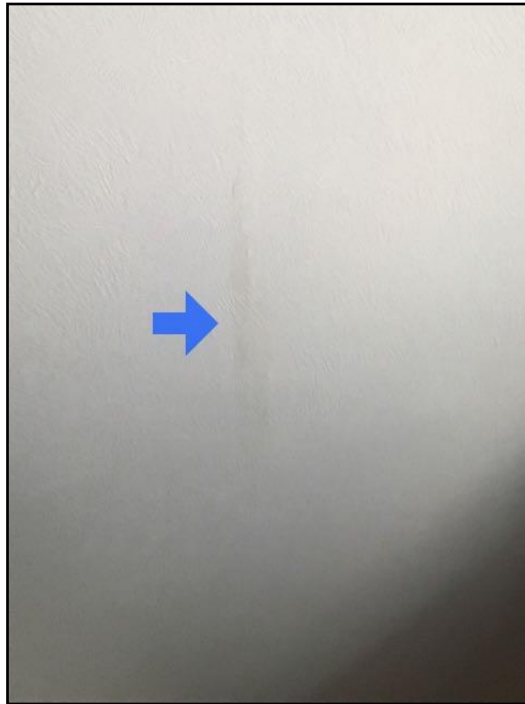
27. Condition: • Water stains noted. This may have been from a previous leak. This area appears to be dry at the time of the inspection. Monitor for leaks and repair as needed. Ask sellers what happened in this area and what was done to prevent it from happening again.

Location: Kitchen

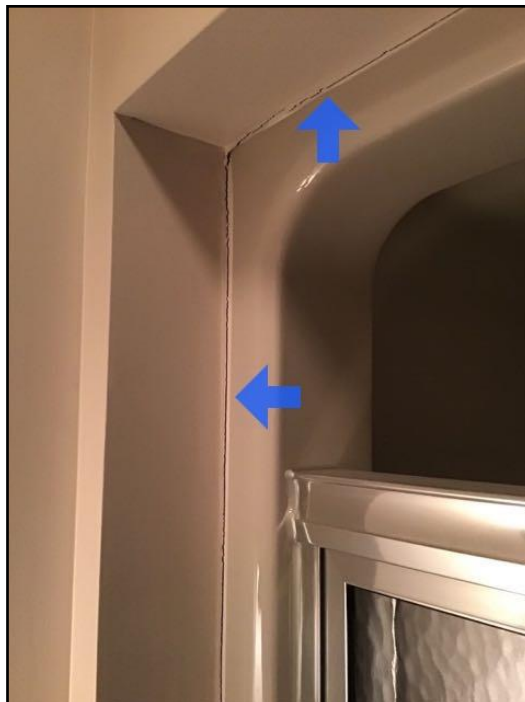
28. Condition: • Caulk loose/deteriorated around shower stall.

Location: Upstairs Shared Bathroom

Task: Caulk as desired

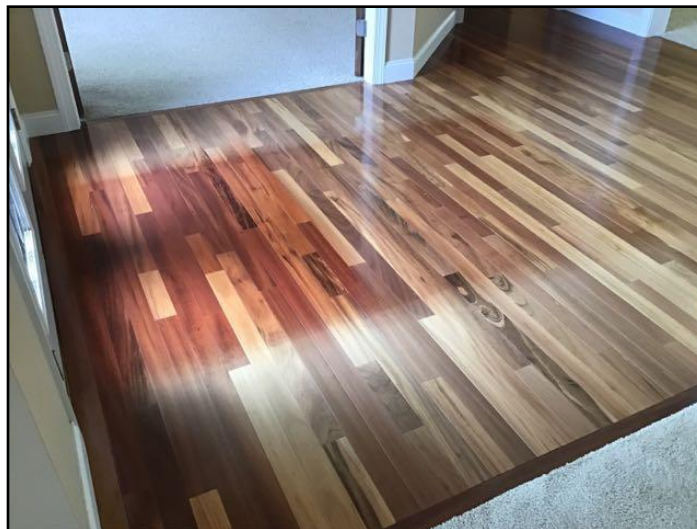
Condition: • Ghosting noted on the floor. Repair area as needed.

31. **Condition:** • Ghosting noted on the floor. Repair area as needed.

Location: Front Entryway

Ghosting noted on the floor. Repair area as...

Task: Repair as desired

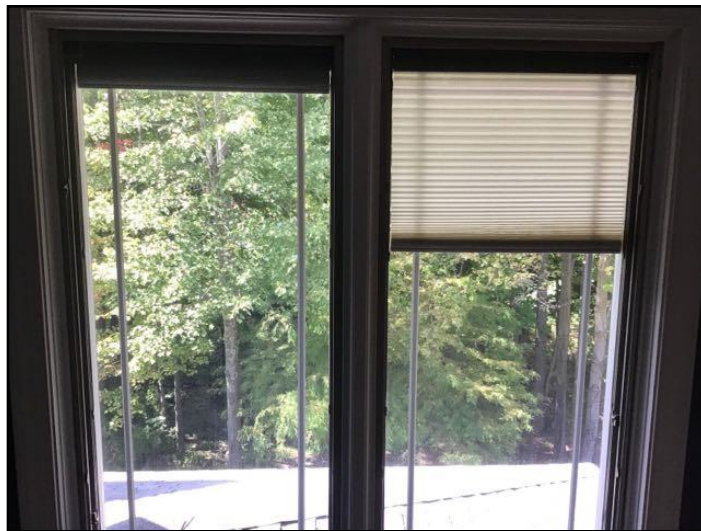
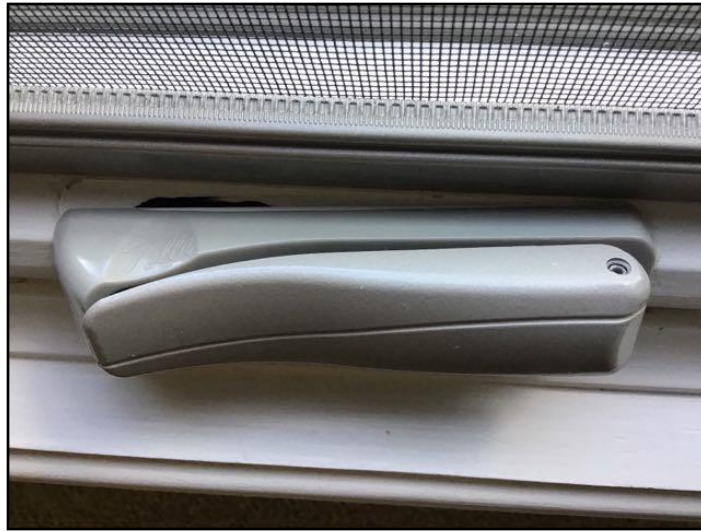
37. Condition: • [Loose](#)

Implication(s): Equipment failure

Loose

Task: Repair as needed

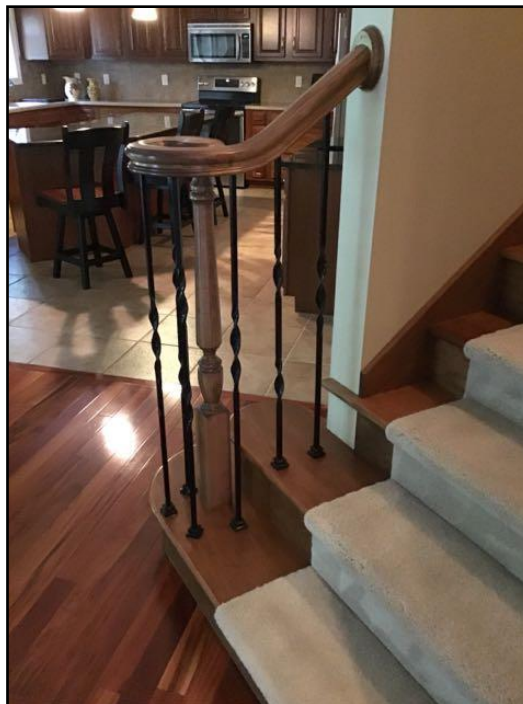
38. Condition: • [Loose](#)

Implication(s): Fall hazard

Location: Main Staircase

Loose

Task: Repair/Secure

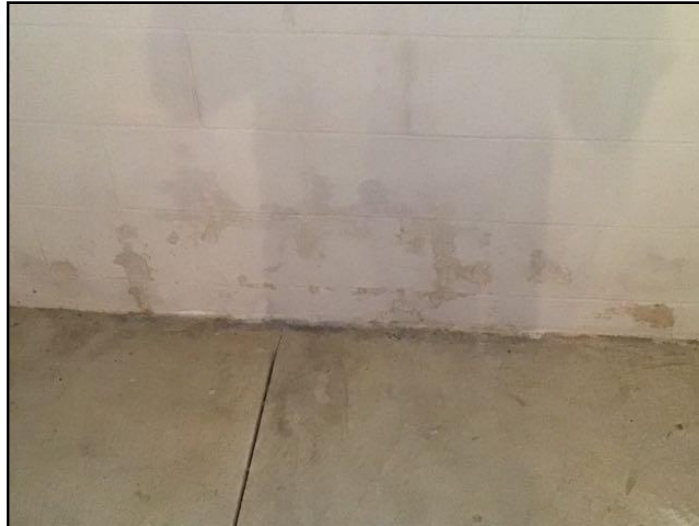
39. Condition: • [Water marks](#)

Monitor for water intrusion and repair as needed.

Implication(s): Chance of water damage to contents, finishes and/or structure

Water marks
