INSPECTION REPORT

For the Property at:
123 MAIN ST.
MANSFIELD, OH 44906

Prepared for: JOHN SMITH
Inspection Date: Monday, September 9, 2019
Prepared by: Joshua Wendling

RE: Report No. 1693
123 Main St.
Mansfield, OH
44906

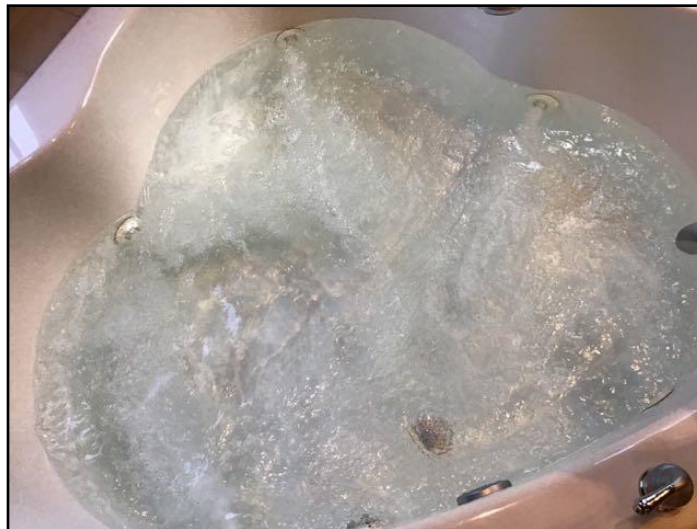
FIXTURES AND FAUCETS \ Whirlpool bath (Hydro-Massage Therapy Equipment)

26. Condition: • Operational at the time of the inspection.
